NTN corporation

Care and Maintenance of Bearings

CAT. No. 3017/E

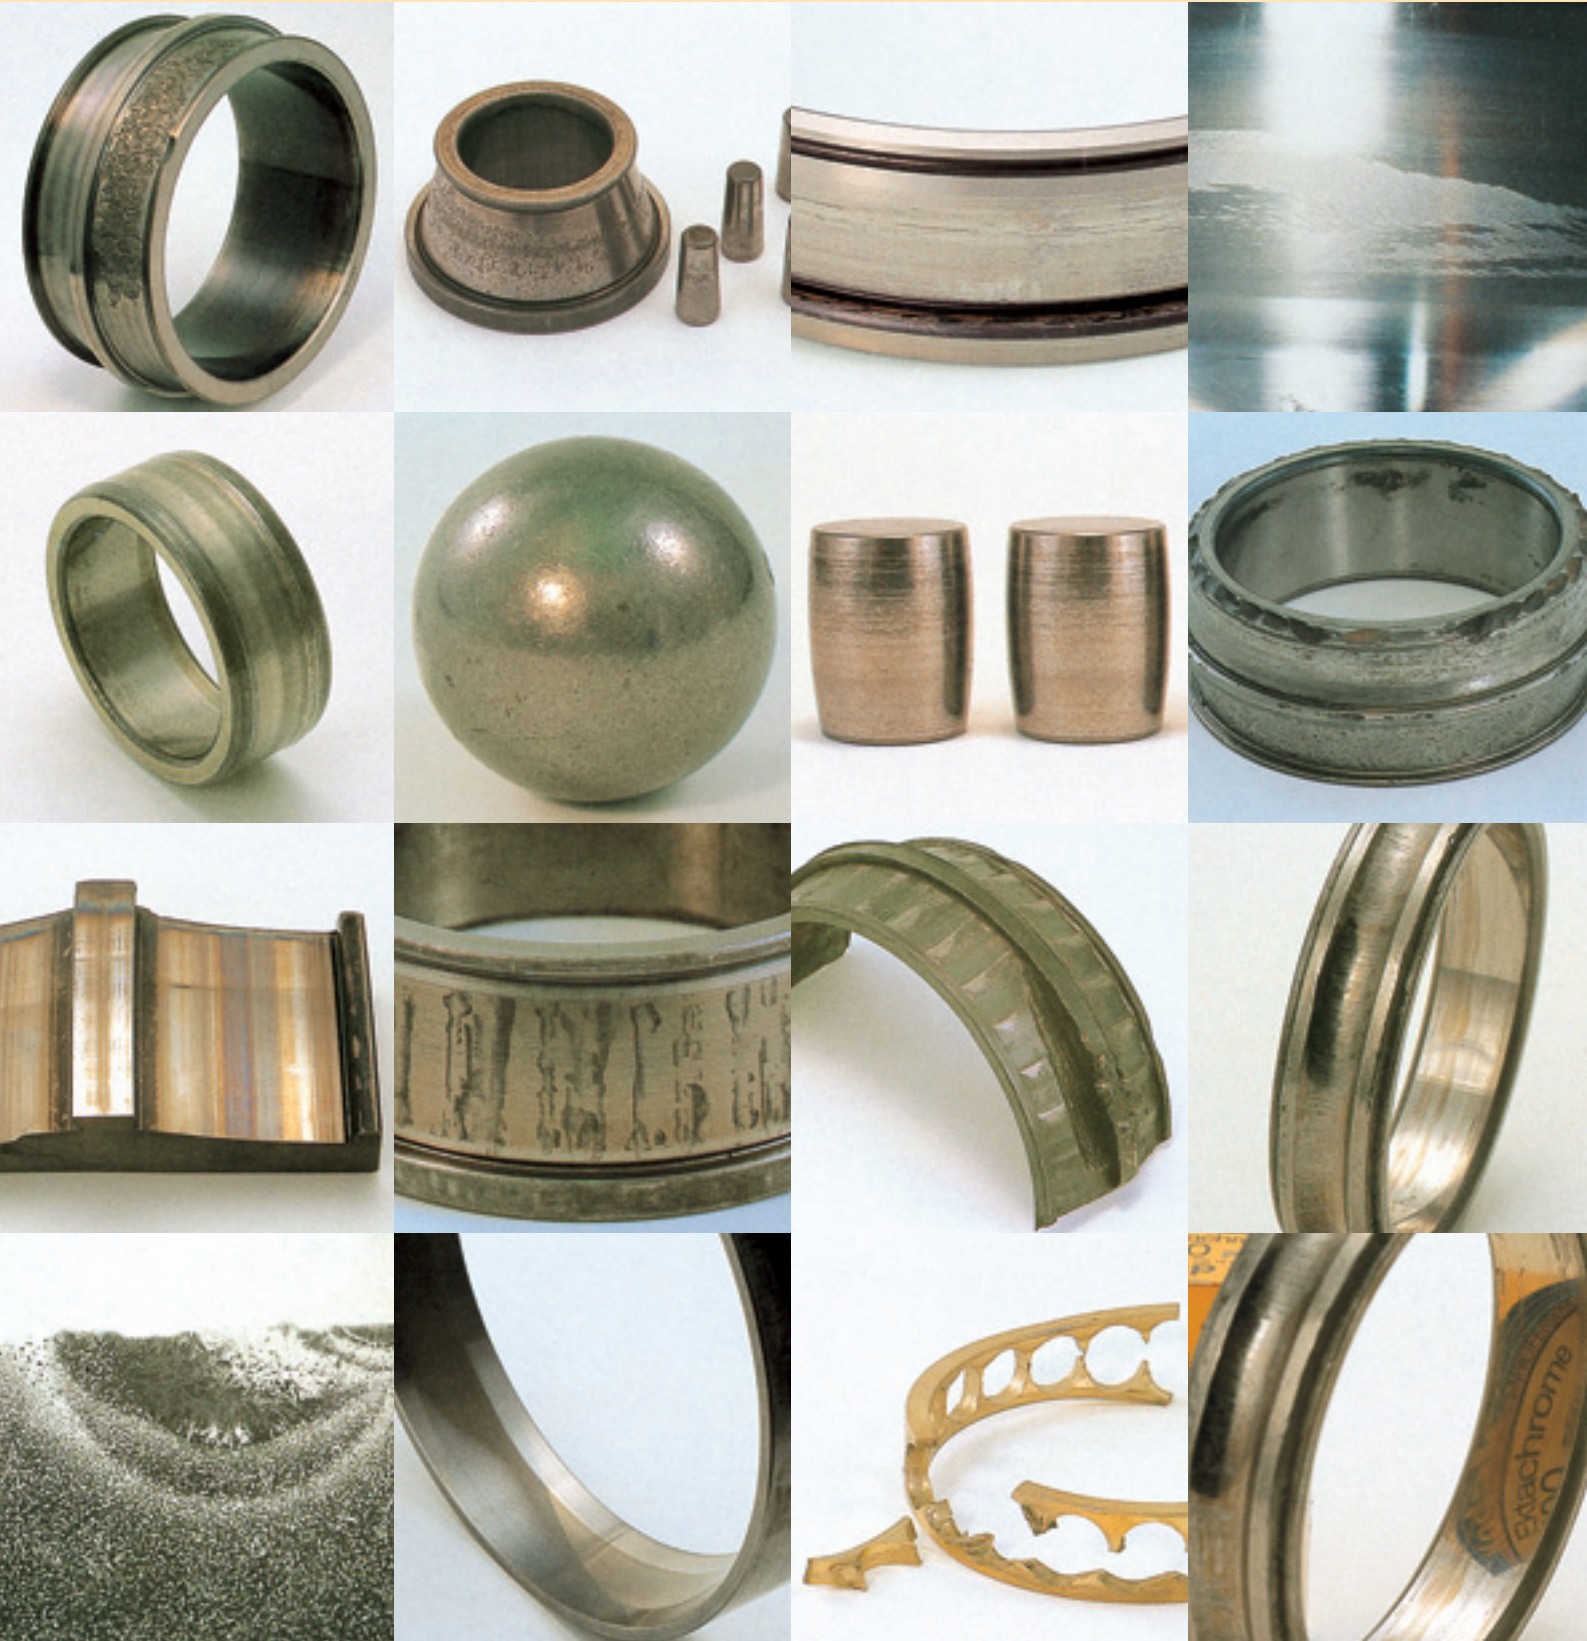
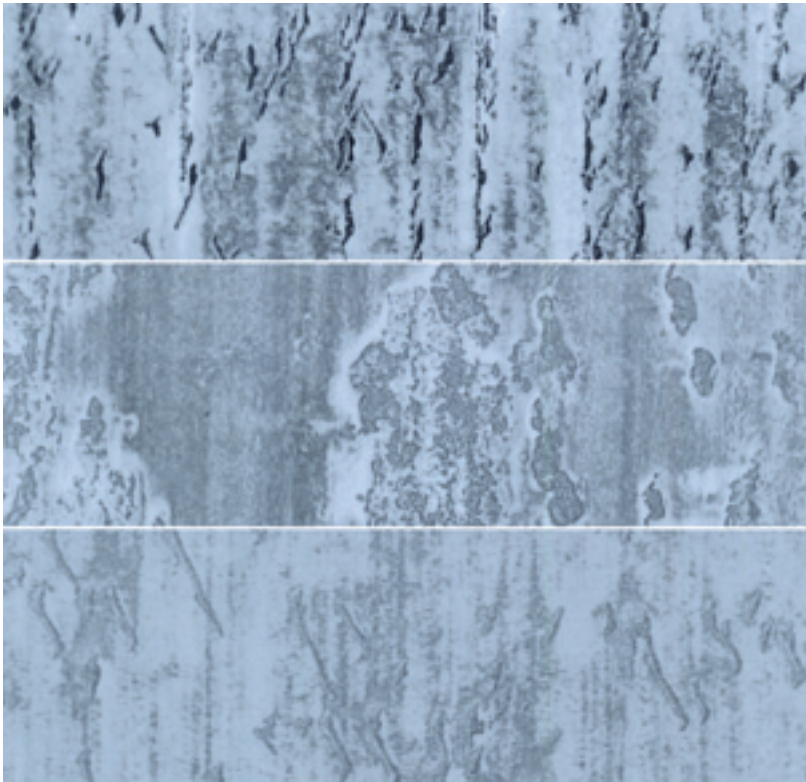
Explanation of the Photos. These are microscopic photographs of peeling damage generated on the surface of a ball/roller bearing. Peeling can occur when the surface roughness is high, or when the lubrication performance is poor. Peeling has a flat-colored appearance, and when observed under a microscope, shows minute flaking and cracks. The top photo shows an example of minute flaking interconnected with cracks. The photo in the middle shows an example of partial separation of the surface, occurring after a number of areas where minute flaking occurred have been connected. This is often seen when grease lubrication is used. The bottom photo shows an example in which a directionality is seen in the minute flaking. The example also shows cracks due to slippage.

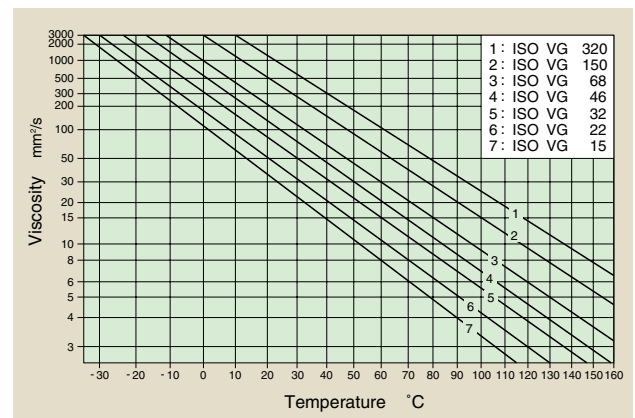
Fig. 3.1 Lubrication oil viscosity-temperature line diagram

Carefully study the viscosity, viscosity index, oxidation resistance, corrosion resistance, foaming resistance, etc. to select an oil. **Table 3.5** gives a guide for selecting viscosity.

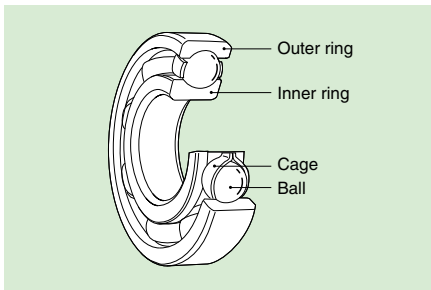
Fig. 5.1 Deep groove ball bearing

Figures 5.1 to 5.7 show the names of bearing parts referred to in the descriptions of the failure cases.

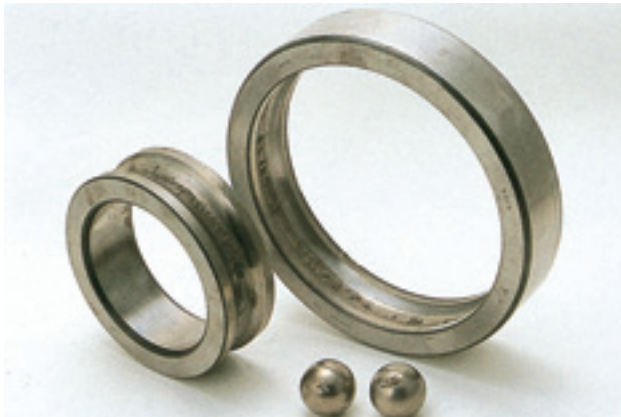
Photo A-1

- Deep groove ball bearing
- Inner ring, outer ring, and balls are flaked.
- The cause is excessive load.

Condition	Cause	Solution
Raceway surface is flaked. Surface after flaking is very rough.	Rolling fatigue. Flaking may be caused early by over-load, excessive load due to improper handling, poor shaft or housing accuracy, installation error, ingress of foreign objects, rusting, etc.	<ol style="list-style-type: none"> (1) Find the cause of the heavy load. (2) Examine operating conditions and adopt bearings with larger capacity as necessary. (3) Increase viscosity of oil and improve lubrication system to form an adequate lubricating oil film. (4) Eliminate installation errors.

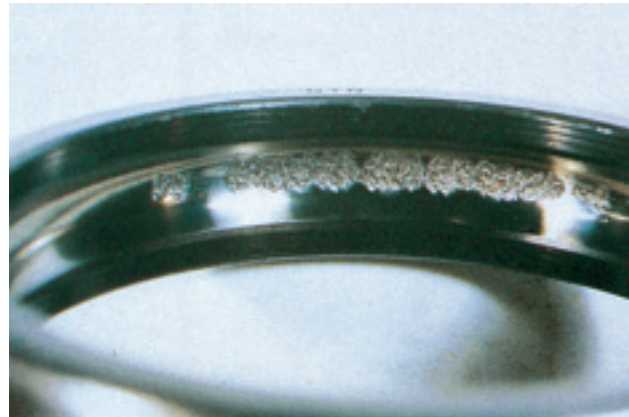
Photo A-2

- Outer ring of angular contact ball bearing
- Flaking of raceway surface spacing equal to distances between balls.
- The cause is improper handling.

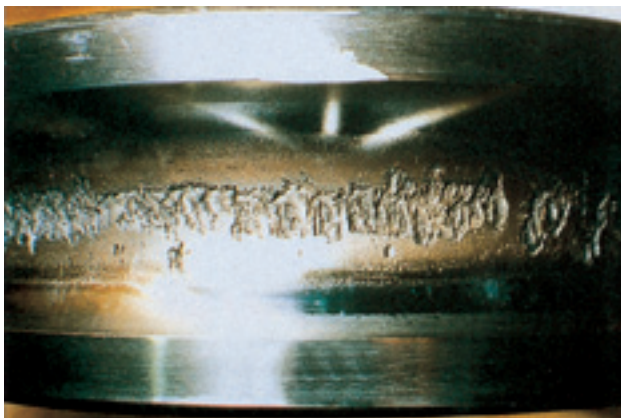
Photo A-3

- Inner ring raceway of a deep groove ball bearing

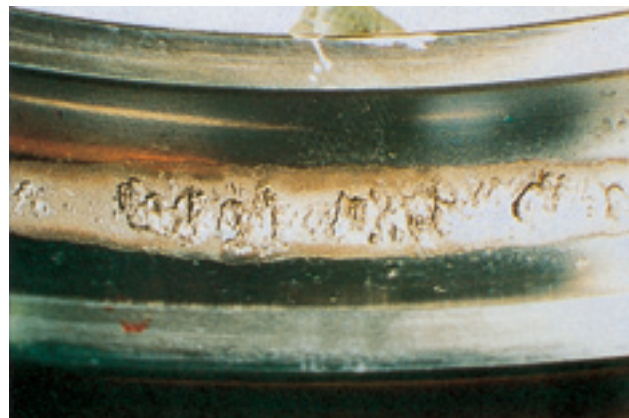
Photo A-4

- Outer ring raceway of an angular contact ball bearing

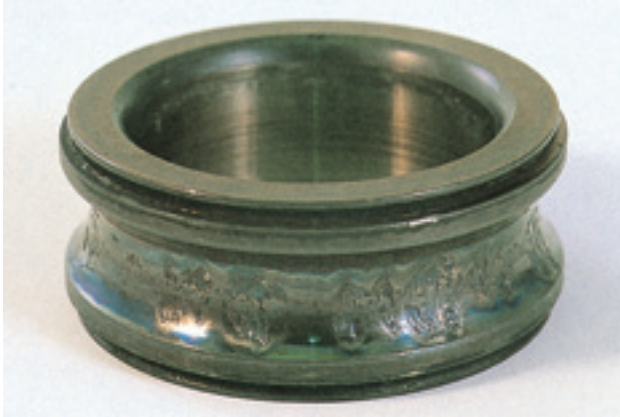
Photo A-5

- Inner ring of deep groove ball bearing
- Flaking on one side of the raceway surface
- The cause is an excessive axial load.

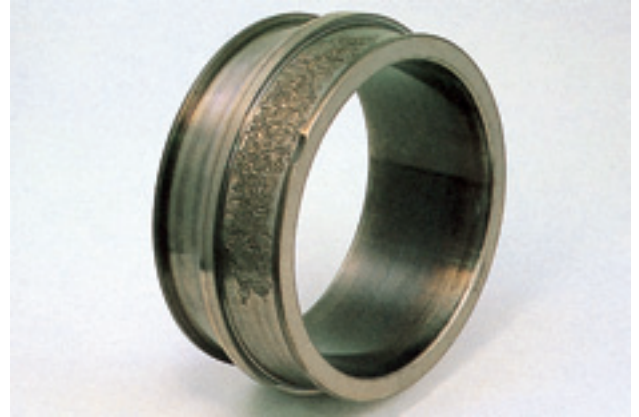
Photo A-6

- Inner ring of spherical roller bearing.
- Flaking only on one side of the raceway surface.
- The cause is an excessive axial load.

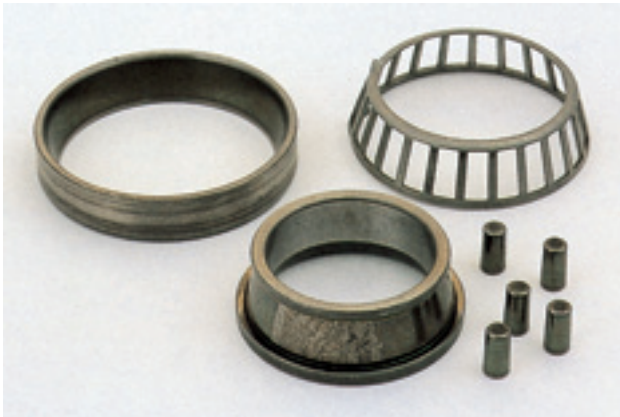
Photo A-7

- Tapered roller bearing
- Flaking on 1/4 circumference of inner ring raceway with outer ring and rollers discolored light brown.
- The cause is excessive pre-load.

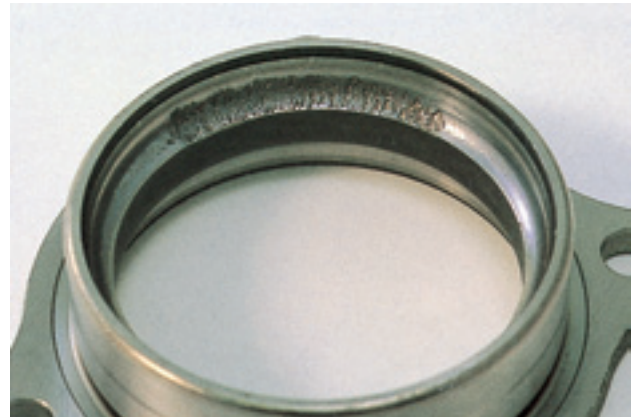
Photo A-8

- Outer ring of double row angular contact ball bearing.
- Flaking on 1/4 circumference of outer ring raceway.
- The cause is poor installation.

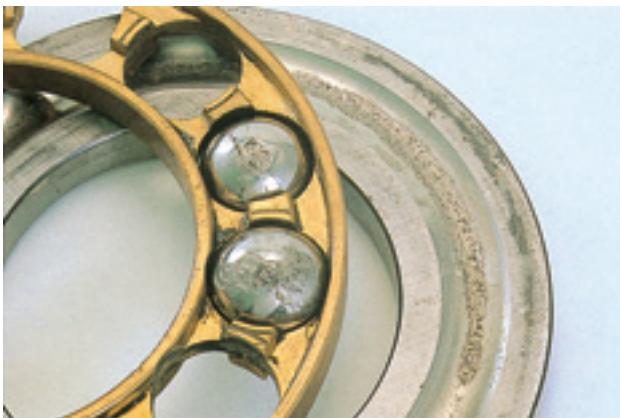
Photo A-9

- Thrust ball bearing
- Flaking on inner ring raceway (bearing ring fastened to shaft) and balls.
- The cause is poor lubrication

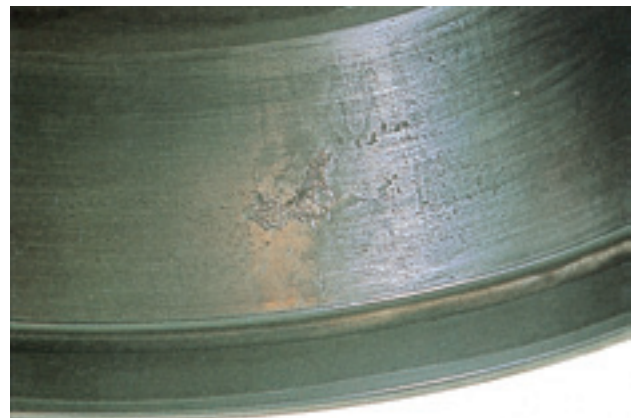
Photo A-10

- Outer ring raceway of double row tapered roller bearing (RCT bearing)
- Flaking originated from electric pitting on the raceway surface (refer to Section 5.13 "Electrical Pitting").

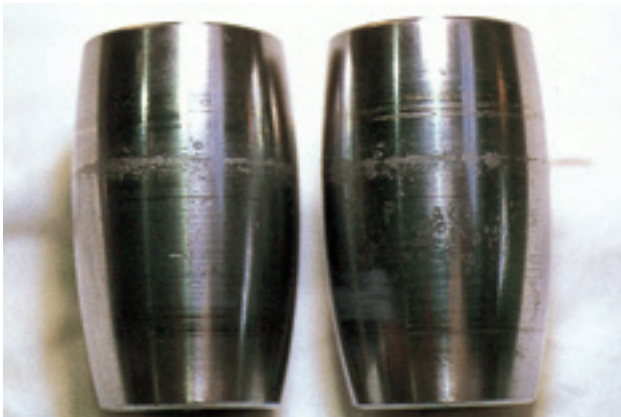
Photo B-1

- Rollers of spherical roller bearing
- Peeling on rolling contact surfaces
- The cause is poor lubrication.

Condition	Cause	Solution
<p>Peeling is a cluster of very small spalls (size about $10\ \mu\text{m}$).</p> <p>Peeling can also include very small cracks which develop into spalls.</p>	<p>Likely to occur in roller bearings.</p> <p>Tends to occur if surface of opposite part is rough or lubrication characteristics are poor.</p> <p>Peeling may develop into flaking.</p>	<p>(1) Control of surface roughness and dust</p> <p>(2) Selection of appropriate lubricant</p> <p>(3) Proper break-in</p>

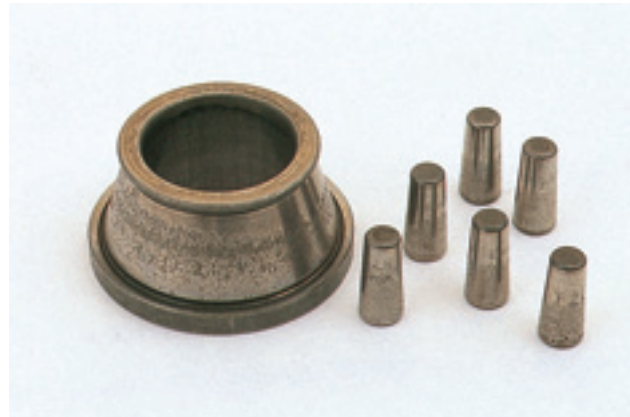
Photo B-2

- Tapered roller bearing
- Development of peeling to flaking on inner ring and rollers
- The cause is poor lubrication.

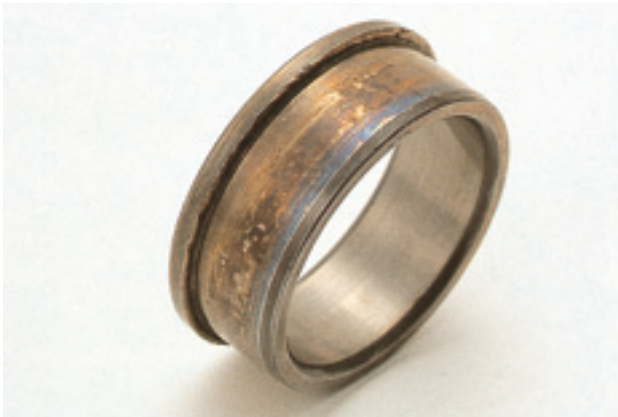
Photo C-1

- Inner ring of cylindrical roller bearing
- Spalling on rib
- The cause is excessive load.

Condition	Cause	Solution
Score accompanying seizing. Mounting score in axial direction. Scores on roller end face and guide rib-cycloidal scores. Scratches in spinning direction on raceway surface and rolling contact surfaces.	Poor mounting and removing practice. Oil film discontinuation on the contact surface due to excessive radial load, foreign object trapping, or excessive pre-load. Slippage or poor lubrication of rolling elements.	(1) Improvement in mounting and removing procedures (2) Improvement in operation conditions (3) Correction of pre-load (4) Selection of adequate lubricant and lubrication system (5) Improvement of sealing efficiency

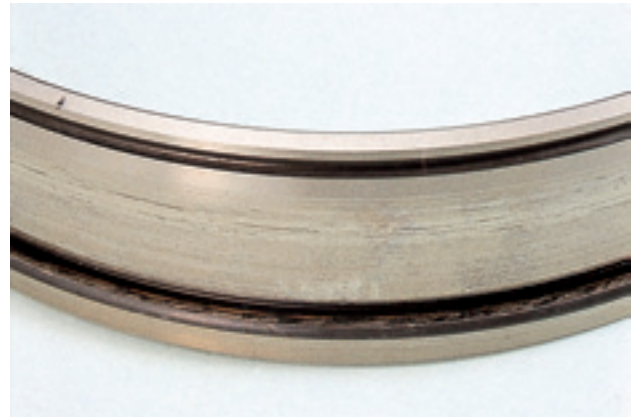
Photo C-2

- Inner ring of cylindrical roller bearing
- Spalling on raceway surface and cone back face rib
- The cause is poor lubrication.

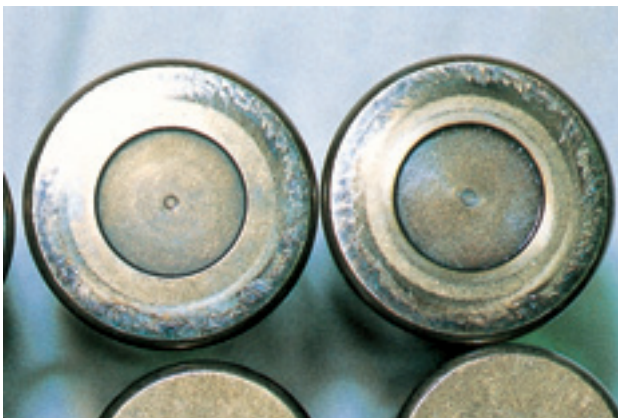
Photo C-3

- Rollers of tapered roller bearing
- Cycloidal spalling on the end faces (Scuffing)
- The cause is poor lubrication.

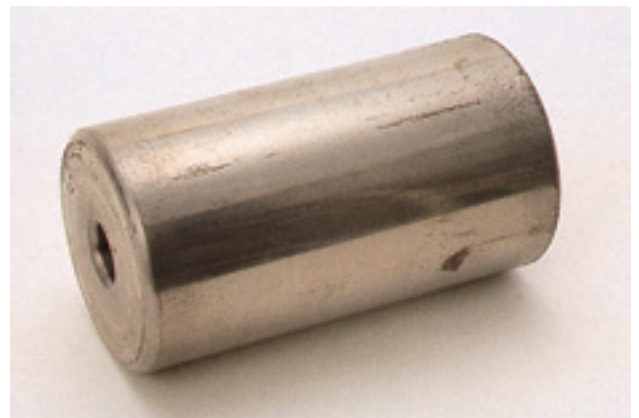
Photo C-4

- Roller of cylindrical roller bearing
- Score in axial direction on rolling contact surface caused during mounting.
- The cause is poor mounting practice.

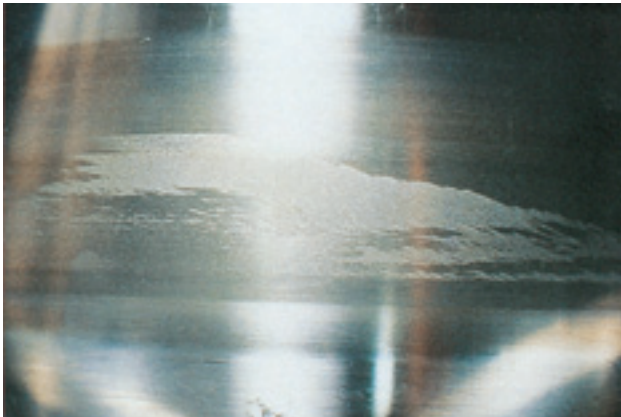
Photo D-1

- Inner ring of cylindrical roller bearing
- Smearing on raceway surface
- The cause is slippage of rollers due to foreign objects trapped within.

Condition	Cause	Solution
Surface is roughened and tiny particles adhere.	Rolling elements slip in rolling motion and characteristics of lubricant are too poor to prevent slippage.	<ol style="list-style-type: none"> (1) Select optimum lubricant and lubrication system capable of forming sound oil film. (2) Use a lubricant including extreme pressure additive. (3) Take precautions such as a small radial clearance and pre-load to prevent slippage.

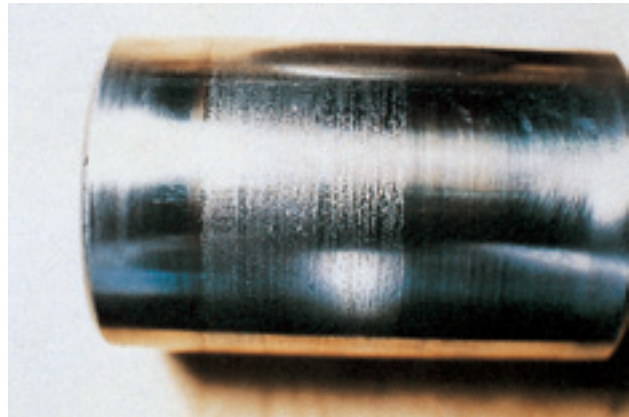
Photo D-2

- Roller of same bearing as that of the inner ring shown in Photo D-1
- Smearing on rolling contact surface
- The cause is slippage of rollers due to foreign objects trapped within.

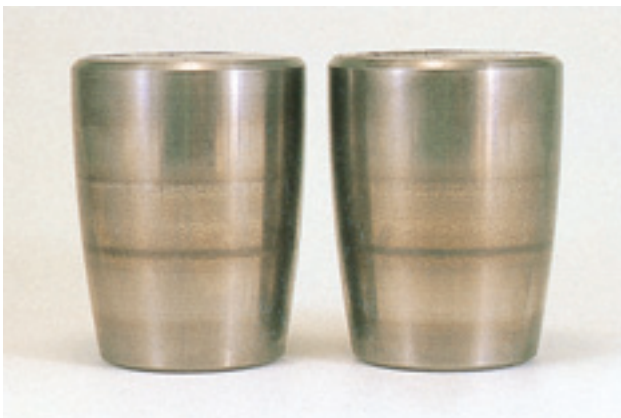
Photo D-3

- Rollers of spherical thrust roller bearings
- Smearing at middle of rolling contact surfaces
- The cause is slippage of rollers due to foreign objects trapped within.

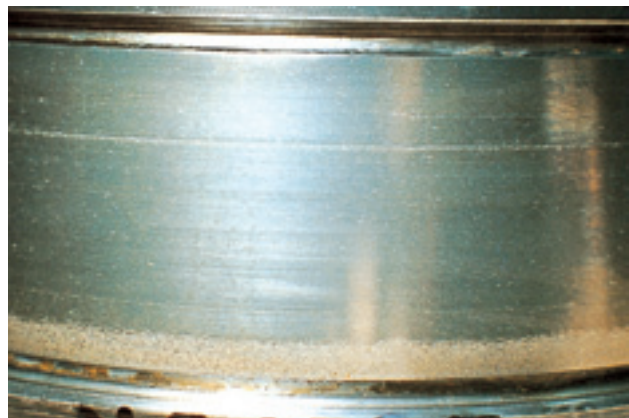
Photo D-4

- Inner ring of double row tapered roller bearing (RCT bearing)
- Smearing on raceway surface

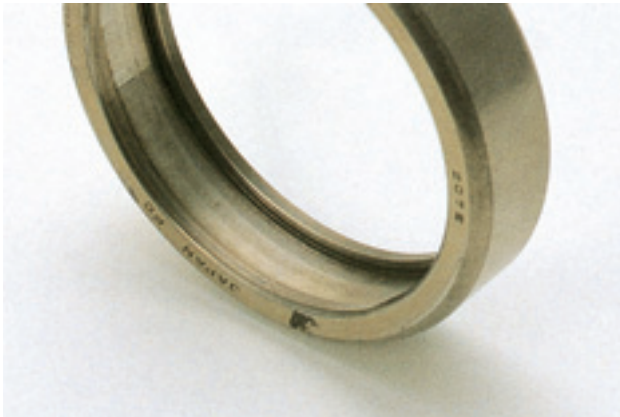
Photo E-1

- Outer ring of cylindrical roller bearing
- Stepped wear on raceway surface
- The cause is poor lubrication.

Condition	Cause	Solution
Surface is worn and dimensions are reduced compared with other portions. Surface mostly roughened and scored.	Ingress of solid foreign objects. Dirt and other foreign objects in lubricant. Poor lubrication. Skewing of rollers.	(1) Selection of optimum lubricant and lubrication system (2) Improvement in sealing efficiency (3) Filtration of lubricating oil (4) Elimination of misalignment

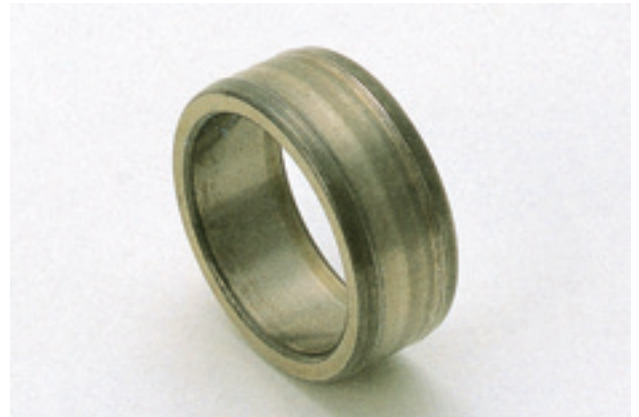
Photo E-2

- Inner ring of cylindrical roller bearing (inner ring of which is shown in Photo E-1)
- Stepped wear on full circumference of raceway
- The cause is poor lubrication.

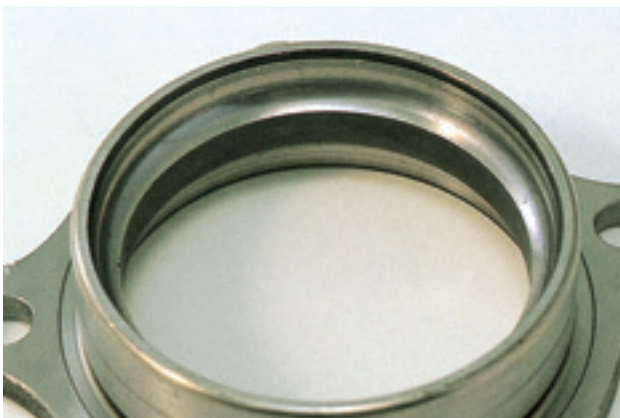
Photo E-3

- Outer ring of double row angular contact ball bearing (hub unit bearing)
- Wear on one side of the raceway
- The cause is poor lubrication.

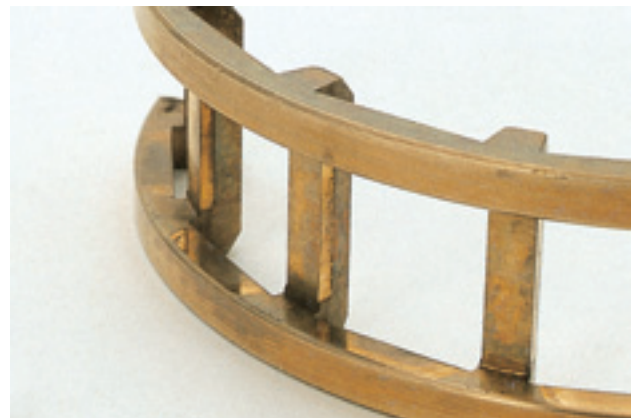
Photo E-4

- Retainer of cylindrical roller bearing
- Wear of pockets of machined high tensile brass casting retainer (G1)

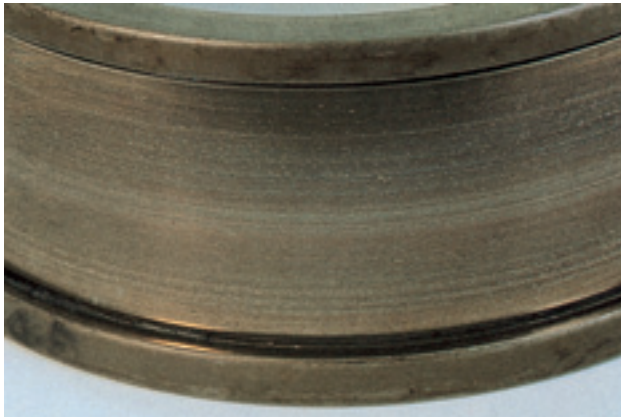
Photo F-1

- Inner ring of double row tapered roller bearing (RCT bearing)
- Raceway surface is speckled
- The cause is electric pitting.

Condition	Cause	Solution
<p>Speckles</p> <p>Raceway surface is matted and speckled.</p> <p>Speckles are clusters of tiny dents.</p> <p>Discoloration</p> <p>The surface color has changed.</p>	<p>Ingress of foreign objects</p> <p>Poor lubrication</p> <p>Temper color by overheating</p> <p>Deposition of deteriorated oil on surface</p>	<p>Speckles</p> <p>(1) Improvement in sealing efficiency</p> <p>(2) Filtration of oil</p> <p>(3) Improvement in lubrication system</p> <p>Discoloration</p> <p>(1) Oil deposition is removable by wiping with an organic solvent (oxalic acid).</p> <p>(2) If roughness is not removable by polishing with sandpaper, it is rust or corrosion. If completely removable, it is temper color due to overheating.</p>

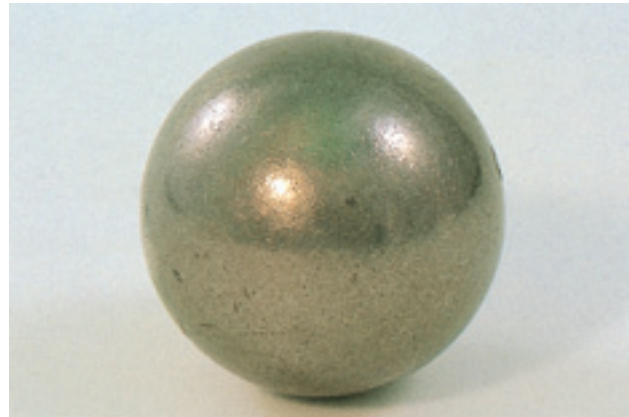
Photo F-2

- Ball of deep groove ball bearing
- Speckled all over
- The cause is foreign objects and poor lubrication

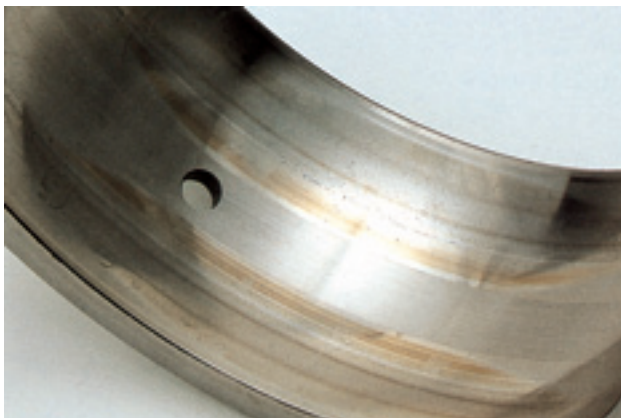
Photo F-3

- Outer ring of spherical roller bearing
- Partial oil deposition on raceway surface

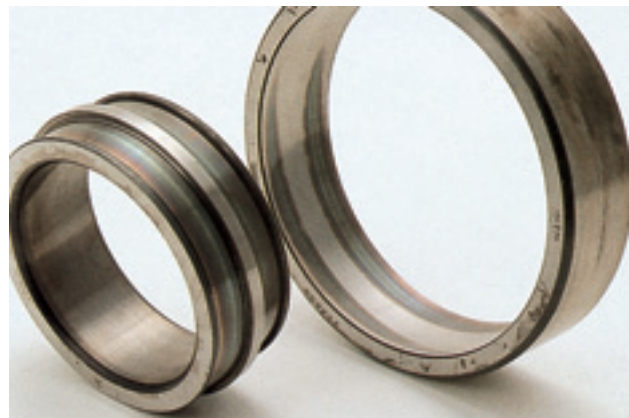
Photo F-4

- Spherical roller bearing
- Discoloration of inner and outer ring raceway surfaces
- The cause is deterioration of lubricant.

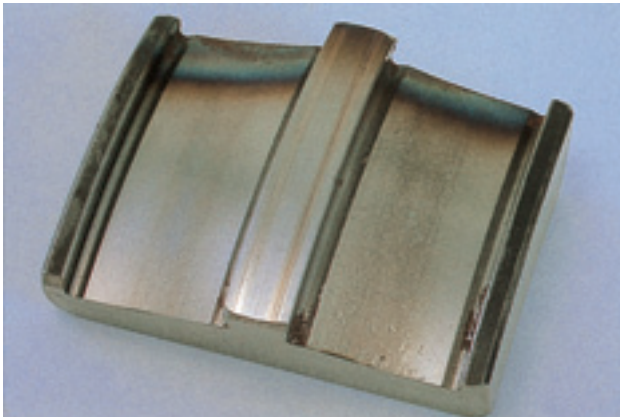
Photo G-1

- Inner ring (cut off piece) of self-aligning roller bearing
- Dents on one side of the raceway
- The cause is trapping of solid foreign objects.

Condition	Cause	Solution
Hollows in raceway surface produced by solid foreign objects trapped or impacts (False brinelling)	Ingress of solid foreign objects Trapping of flaked particles Impacts due to careless handling	(1) Keeping out foreign objects (2) Check involved bearing and other bearings for flaking if dents are produced by metal particles. (3) Filtration of oil (4) Improvement in handling and mounting practices

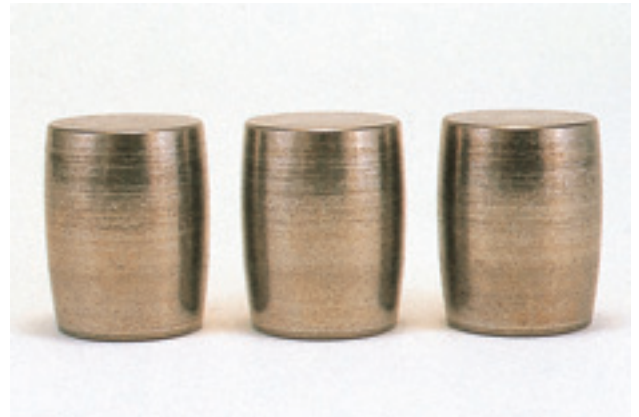
Photo G-2

- Rollers of spherical roller bearing
- Dents on rolling contact surfaces
- The cause is trapping of solid foreign objects.

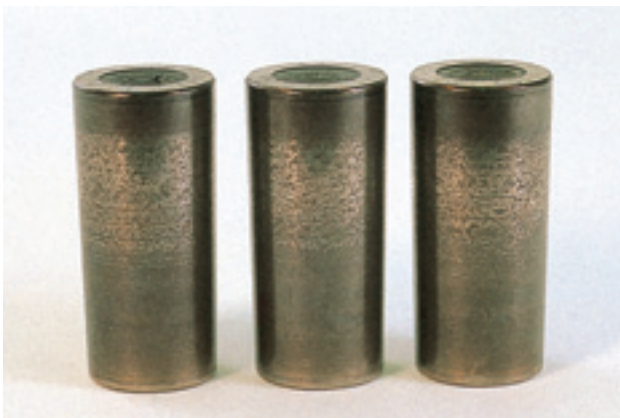
Photo G-3

- Rollers of tapered roller bearings
- Dents all over rolling contact surfaces. (Temper color at two ends.)
- The cause is foreign objects carried by lubricating oil.

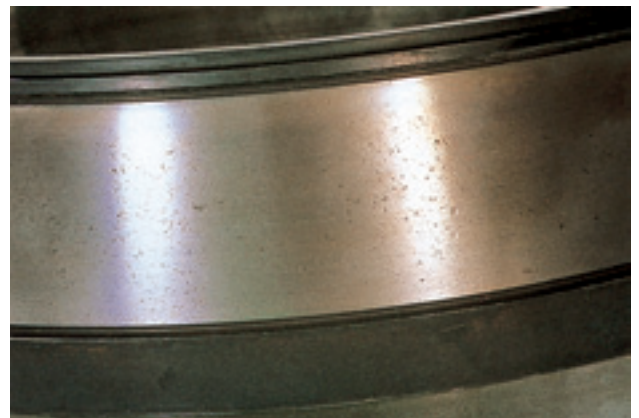
Photo G-4

- Inner ring of tapered roller bearing
- Dents on raceway surface
- The cause is trapping of foreign objects.

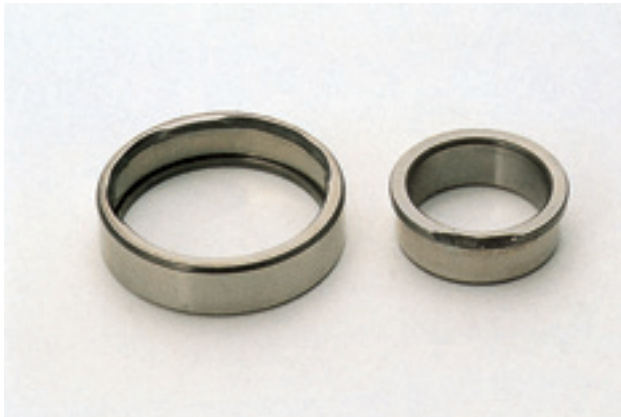
Photo H-1

- Cylindrical roller bearing
- Chipping of guide ribs of inner and outer rings
- The cause is excessive impact load.

Condition	Cause	Solution
Partial chipping of inner ring, outer ring, or rolling elements.	Trapping of large solid foreign objects Impacts or excessive load Poor handling	(1) Trouble shooting and improvements of impacts and excessive load (2) Improvement in handling (3) Improvement in sealing characteristics

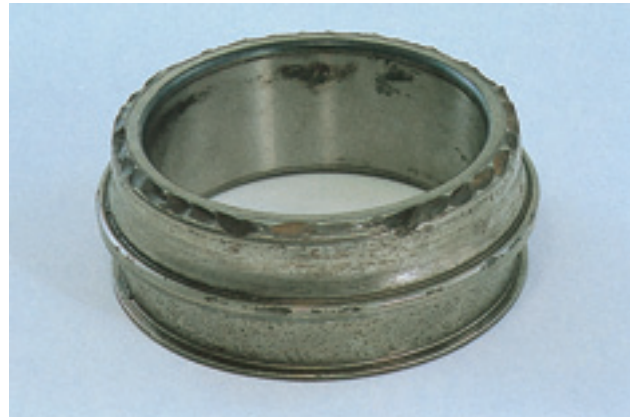
Photo H-2

- Inner ring of spherical roller bearing
- Rib chipped
- The cause is excessive impact load.

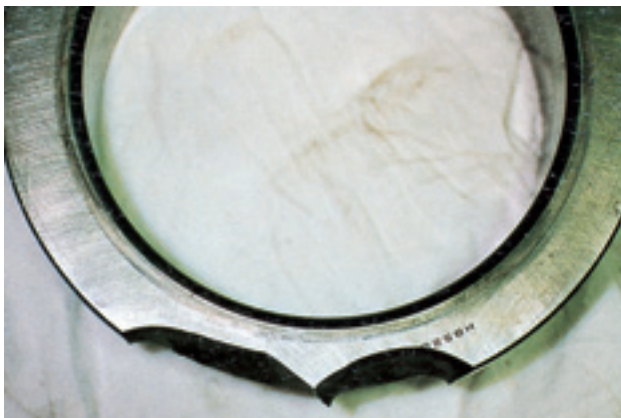
Photo H-3

- Inner ring of tapered roller bearing
- Chipping of cone back face rib
- The cause is impact due to poor mounting.

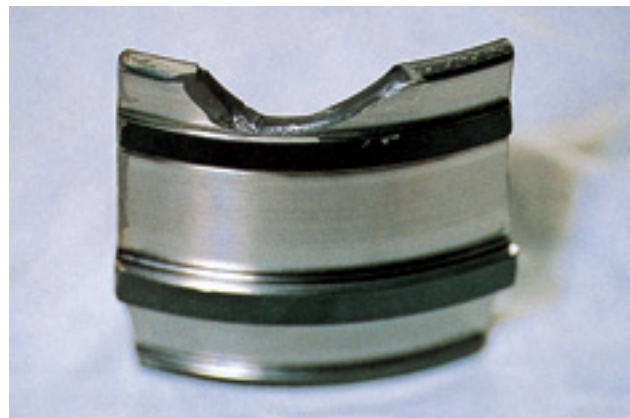
Photo H-4

- Inner ring of double row tapered roller bearing
- Chipping of side face
- The cause is impact due to improper handling.

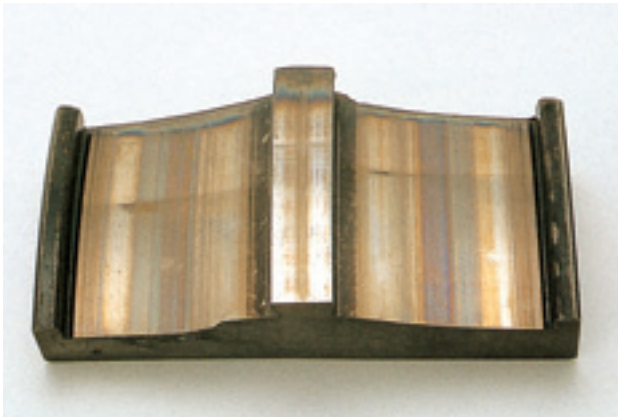
Photo I-1

- Inner ring of spherical roller bearing
- Split of raceway surface in the axial direction
- The cause is excessive interference fit.

Condition	Cause	Solution
Splits, and cracks in bearing rings and rolling elements.	Excessive load Excessive impacts Overheating by creeping and rapid cooling Very loose fit Large flaking	(1) Examination and improvement of cause of very large load (2) Prevention of creep (3) Correction of fit

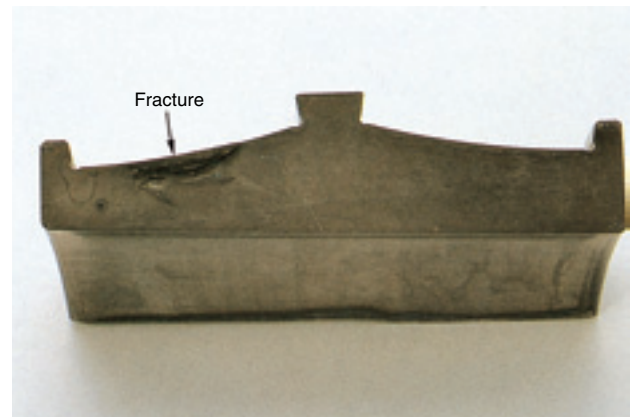
Photo I-2

- Fracture of inner ring shown in Photo I-1
- Originating point is observed at the middle of the left raceway surface.

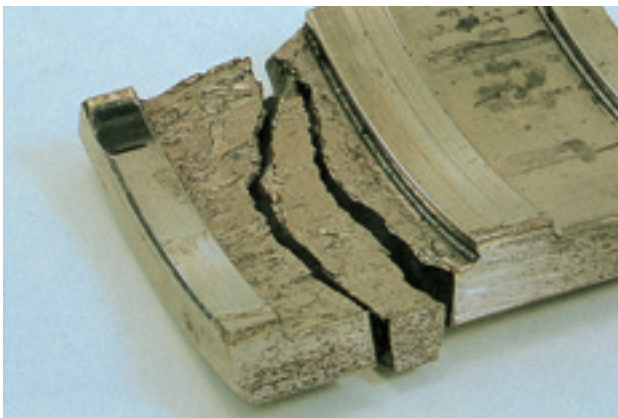
Photo I-3

- Outer ring of four-row cylindrical roller bearing
- Split of raceway surface in the circumferential direction, originated from large flaking.
- The cause is large flaking.

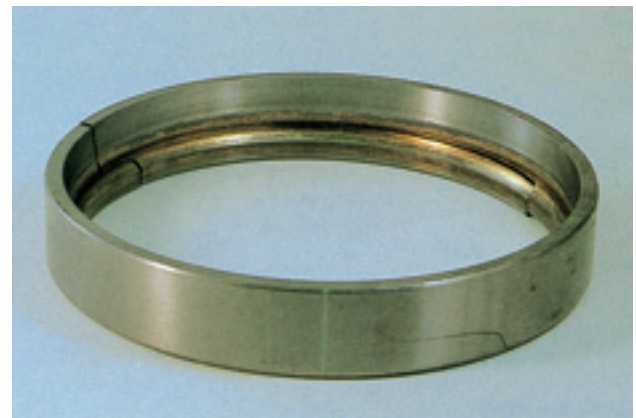
Photo I-4

- Outer ring of angular contact ball bearing
- Split of raceway surface in the circumferential direction
- The cause is slipping of balls due to poor lubrication.

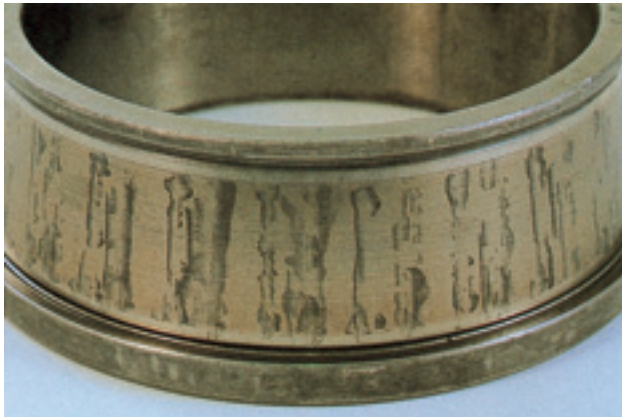
Photo J-1

- Inner ring of tapered roller bearing
- Rusting on raceway surface spacing equivalent to the distance between rollers. The cause is water in lubricant.

Condition	Cause	Solution
<p>Rusting or corrosion of bearing ring and rolling element surfaces</p> <p>Sometimes rusted at spacing equal to the distances between the rolling elements</p>	<p>Ingress of water or corrosive material (such as acid)</p> <p>Condensation of moisture contained in the air.</p> <p>Poor packaging and storing conditions, and handling with bare hands.</p>	<p>(1) Improvement in sealing effect</p> <p>(2) Periodic inspection of lubricating oil</p> <p>(3) Careful handling of bearing</p> <p>(4) Measures for preventing rusting when not operating for a long period of time.</p>

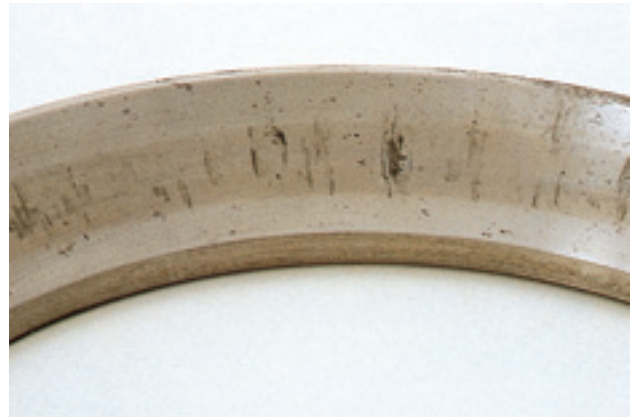
Photo J-2

- Outer ring of tapered roller bearing
- Rusting on raceway surface spacing equivalent to the distances between rollers. The cause is water in lubricant. Some points are corroded.

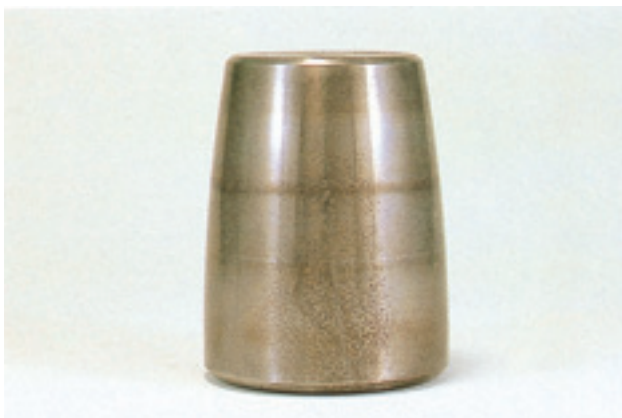
Photo J-3

- Roller of spherical roller bearing
- Rust as well as corrosion on rolling contact surface
- Ingress of water

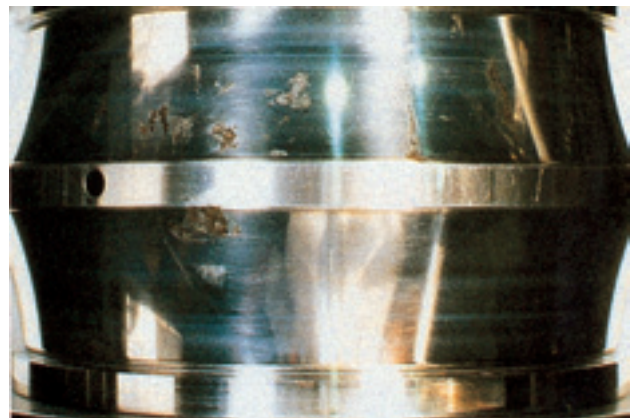
Photo J-4

- Inner ring (split type) of self-aligning roller bearing
- Rust and corrosion of the raceway surface
- The cause is ingress of water.

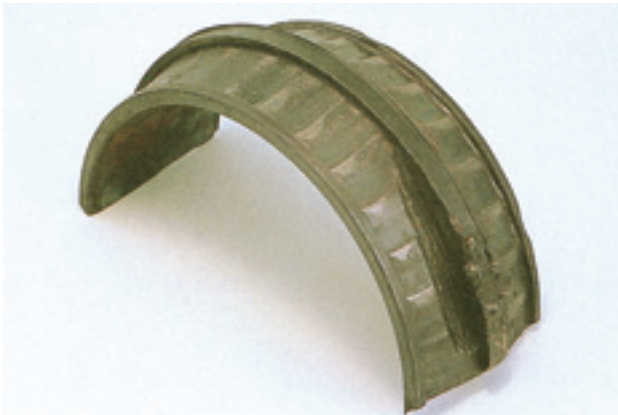
Photo K-1

- Inner ring of double row tapered roller bearing
- Seizing-up discolors and softens inner ring producing stepped wear at spacing equal to distances between the rollers.
- The cause is poor lubrication.

Condition	Cause	Solution
<p>Bearing generates heat and is seized up by heat disabling spinning.</p> <p>Discoloration, softening, and welding of raceway surface, rolling contact surfaces, and rib surface.</p>	<p>Dissipation of heat generated by bearing is not enough. Poor lubrication or lubricant improper. Clearance excessively small.</p> <p>Excessive load (or pre-load),</p> <p>Roller skewing and installation error.</p>	<p>(1) Improve dissipation of heat from bearing</p> <p>(2) Selection of suitable lubricant and determination of optimum lubricant feeding rate.</p> <p>(3) Prevention of misalignment</p> <p>(4) Improvement in clearance and pre-load</p> <p>(5) Improvement in operating conditions</p>

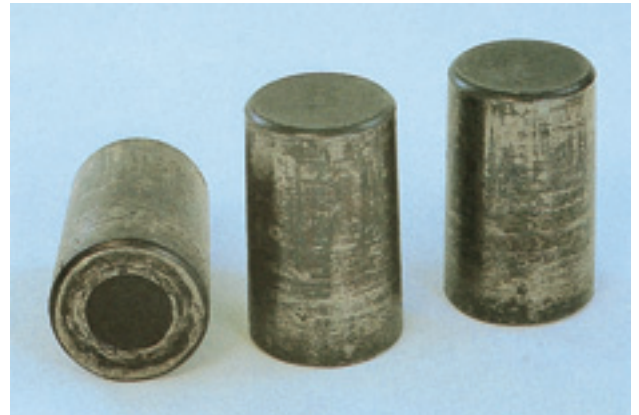
Photo K-2

- Rollers of double row tapered roller bearing
- Rollers of same bearing as that of the inner ring shown in Photo K-1. Discoloration, spalling, and adhesion due to seizing up on rolling contact surfaces and end faces of rollers.

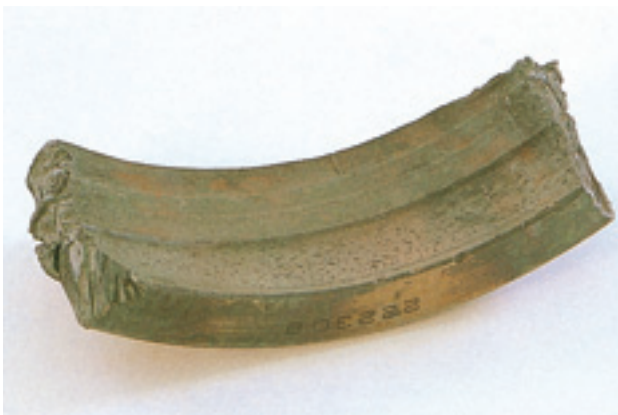
Photo K-3

- Outer ring of spherical roller bearing
- Stepped wear due to seizing up of raceway surface.
- The cause is poor lubrication.

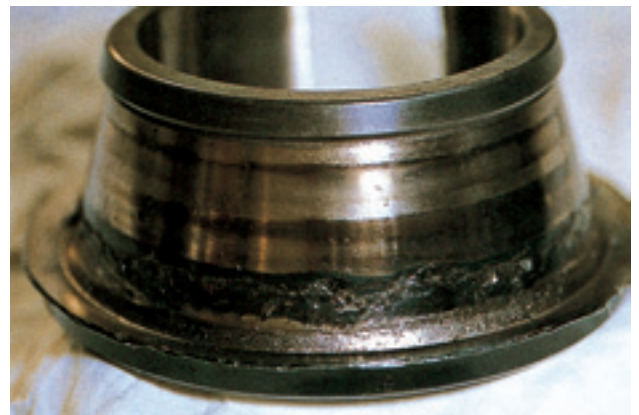
Photo K-4

- Inner ring of tapered roller bearing
- Large end of the race way surface and cone back face rib surface are seized up.
- The cause is poor lubrication.

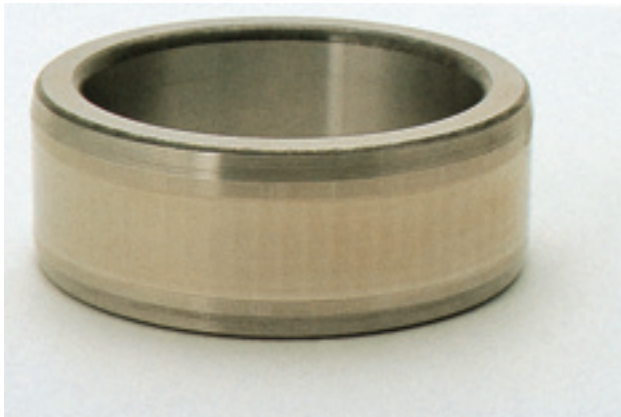
Photo L-1

- Inner ring of cylindrical roller bearing.
- Corrugated fretting along full circumference of raceway.
- The cause is vibration.

Condition	Cause	Solution
<p>Fretting surfaces wear producing red rust colored particles that form hollows.</p> <p>On the raceway surface, dents called false brinelling are formed at spacing equal to distances corresponding to the rolling elements.</p>	<p>If a vibrating load works on contacting elements resulting in small amplitude oscillation, lubricant is driven out from contact, and parts are worn remarkably.</p> <p>Oscillation angle of the bearing is small.</p> <p>Poor lubrication (no lubrication)</p> <p>Fluctuating load</p> <p>Vibration during transportation</p> <p>Vibration, shaft deflection, installation error, loose fit.</p>	<p>(1) Inner ring and outer ring should be packaged separately for transportation. If not separable, bearings should be preloaded.</p> <p>(2) Use oil or high consistency grease when bearings are used for oscillation motion.</p> <p>(3) Change lubricant</p> <p>(4) Fix shaft and housing</p> <p>(5) Improve fit</p>

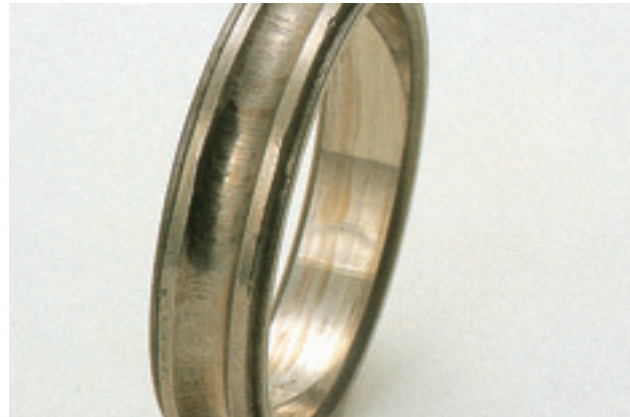
Photo L-2

- Inner ring of deep groove ball bearing.
- Fretting along full circumference of raceway.
- The cause is vibration.

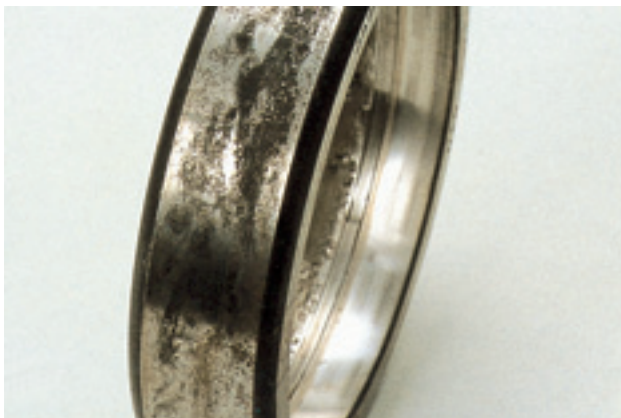
Photo L-3

- Outer ring of cylindrical roller bearing
- Fretting rust on outside diameter surface

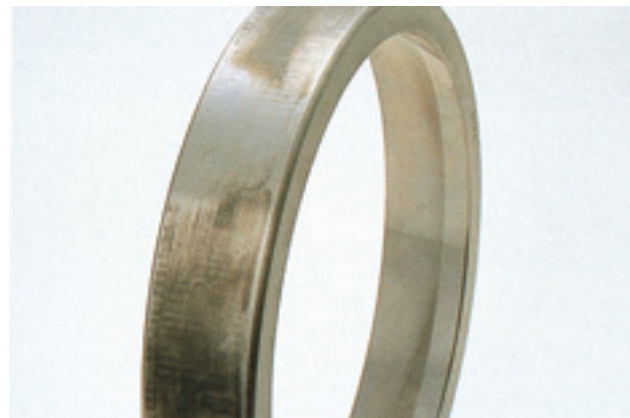
Photo L-4

- Outer ring of tapered roller bearing
- Fretting rust on the outside diameter surface

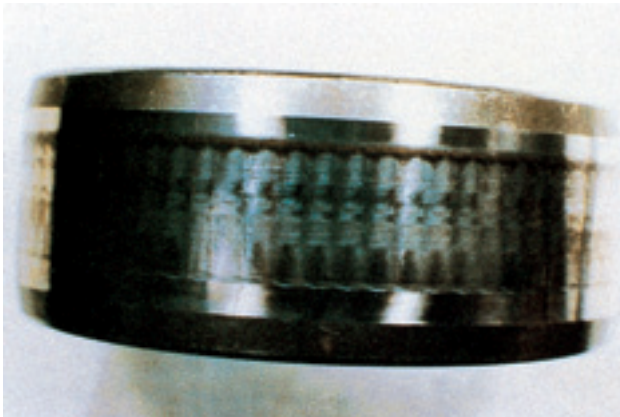
Photo M-1

- Inner ring of cylindrical roller bearing
- Raceway surface is corrugated by electric pitting

Condition	Cause	Solution
<p>Surface is speckled visually and the speckles are clusters of tiny pits when viewed through a microscope.</p> <p>Further development leads to a corrugated surface.</p>	<p>Electric current passes through bearing, and sparks are generated to fuse the raceway surface .</p>	<p>Avoid flow of electric current by averting current with a slip ring or insulation bearing.</p>

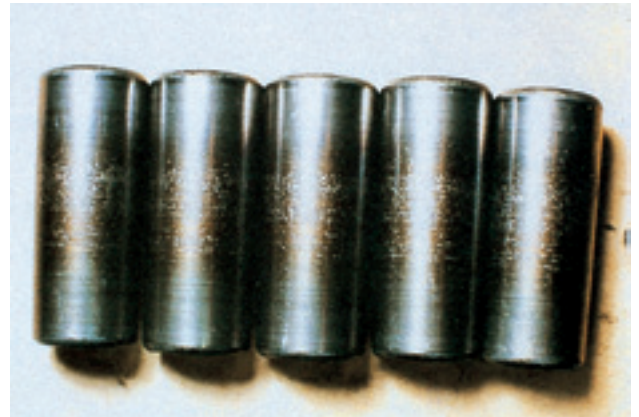
Photo M-2

- Rollers of tapered roller bearings
- Electric pitting at middle of rolling contact surfaces

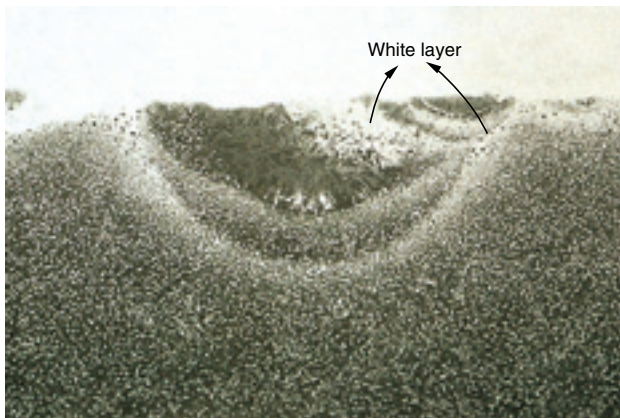
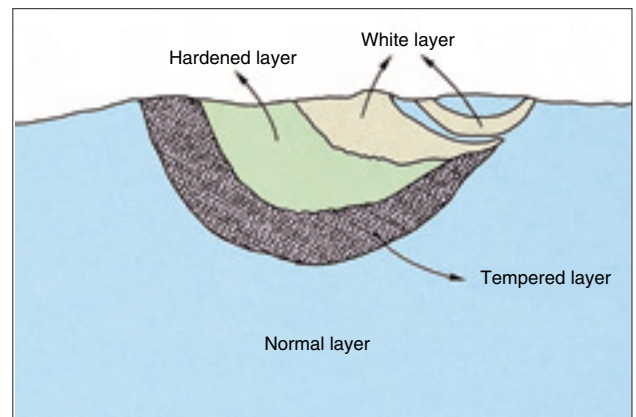
Photo M-3

- Magnified (x400) pitting of roller shown in Photo M-2
- Nital etchant develops a white layer on the cross section

Explanation of magnified photo M-3
