NTN corporation

Care and Maintenance of Bearings

CAT. No. 3017/E

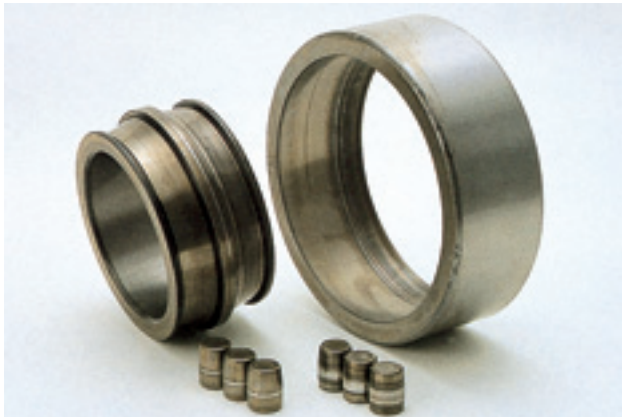
Photo N-1

- Spherical roller bearing
- Contacts on inner ring, outer ring, and rollers are not even.
- The cause is poor mounting.

Condition	Cause	Solution
Rolling element contact path on raceway surface strays or skews.	Deformation or tilt of bearing ring due to poor accuracy of shaft or housing Poor rigidity of shaft or housing Deflection of shaft due to excessive clearance	(1) Improvement in machining accuracy of shaft and housing (2) Improvement in rigidity of shaft and housing (3) Employment of adequate clearance

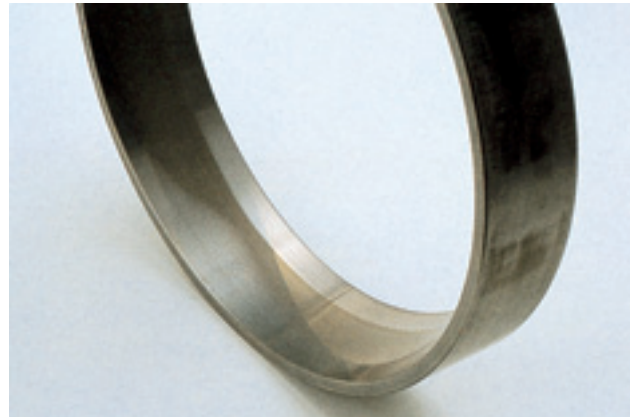
Photo N-2

- Outer ring of tapered roller bearings
- Contact path on raceway surface strays.
- The cause is poor mounting.

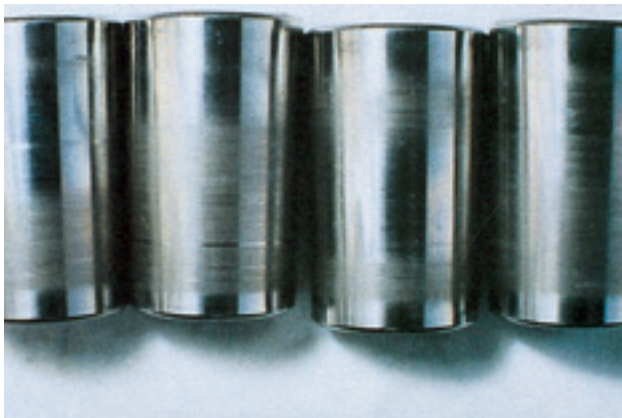
Photo N-3

- Rollers of tapered roller bearing of which outer ring is shown in Photo N-2.
- Contact marks on rolling contact surfaces are not even.

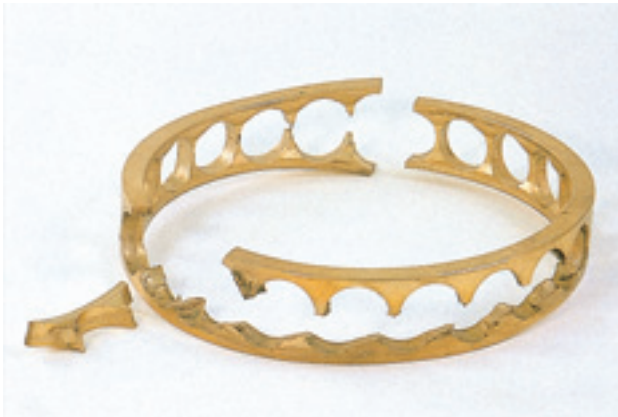
Photo O-1

- Retainer of angular contact ball bearing
- Breakage of machined high tension brass casting retainer L1
- The cause is poor lubrication.

Condition	Cause	Solution
Breaking of retainer <ul style="list-style-type: none"> • Wear of pockets or guide • Loosening or breaking of rivet 	Excessive moment load High speed spinning or large fluctuation of speed Poor lubrication Trapping of foreign objects Heavy vibration Poor mounting (cocked bearing) Excessive heat (plastic retainer in particular)	(1) Improvement in load conditions (2) Improvement in lubrication system and lubricant (3) Selection of optimum retainer (4) Improvement in handling (5) Study on rigidity of shaft and housing

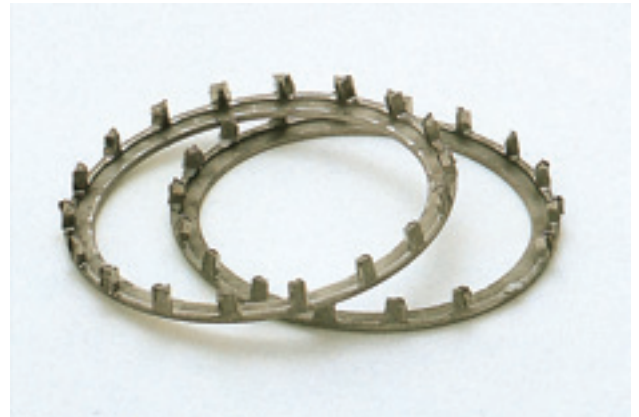
Photo O-2

- Retainer of spherical roller bearing
- Breakage of partitions between pockets of pressed steel retainer

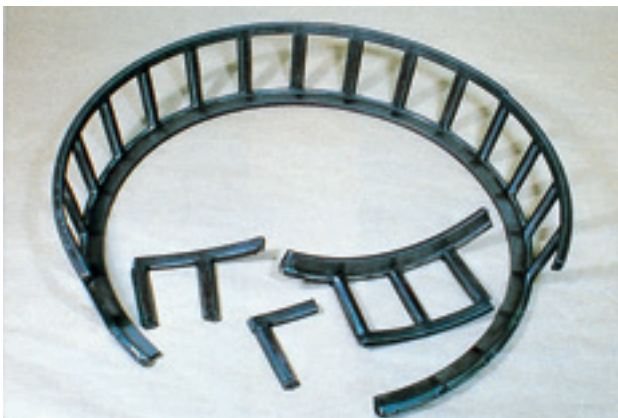
Photo O-3

- Retainer of tapered roller bearing
- Breakage of pockets of pressed steel retainer

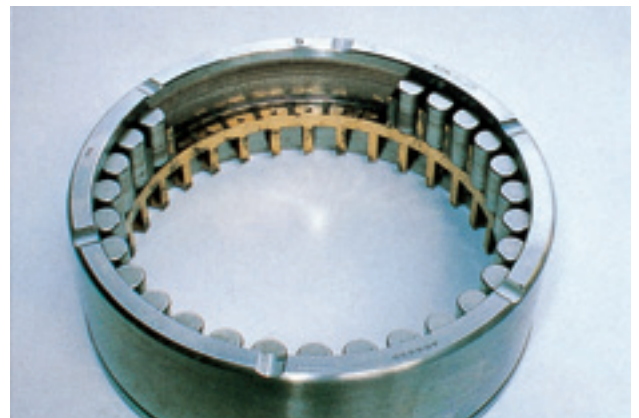
Photo O-4

- Retainer of cylindrical roller bearing
- Breakage of partitions between pockets of machined high tension brass casting retainer L1.

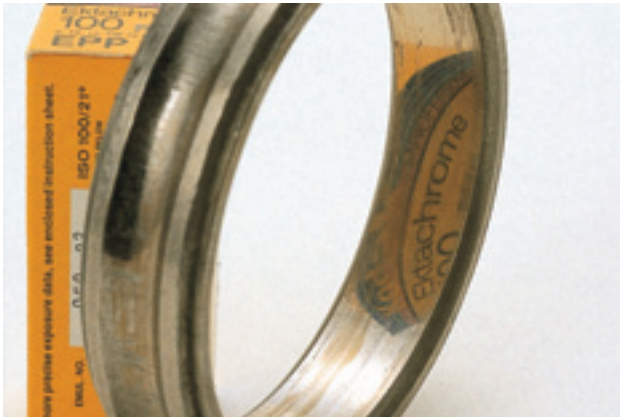
Photo P-1

Condition	Cause	Solution
Fitting surfaces are glazed or matted, and sometimes spalled as well.	Fitting of inner ring is loose on inner ring drive bearing, and that of the outer ring is loose on outer ring drive bearing. If the housing is made of a light alloy such as aluminum, fit may become loose due to the difference of thermal expansion.	<ol style="list-style-type: none"> (1) Improvement in fit (2) Improvement in machining accuracy of shaft and housing

- Inner ring of deep groove ball bearing
- Bore wall glazed by creep

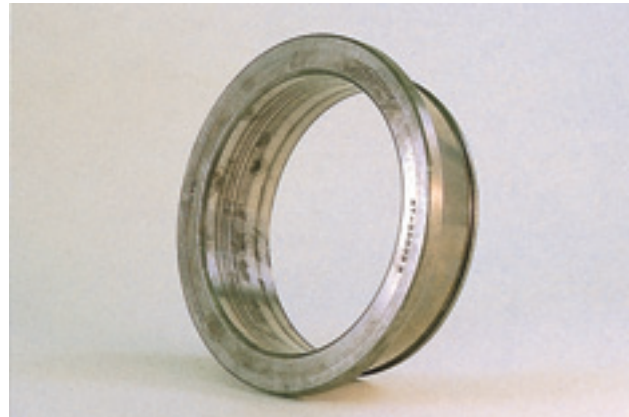
Photo P-2

- Inner ring of tapered roller bearing
- Spalling due to creep at the middle of bore wall

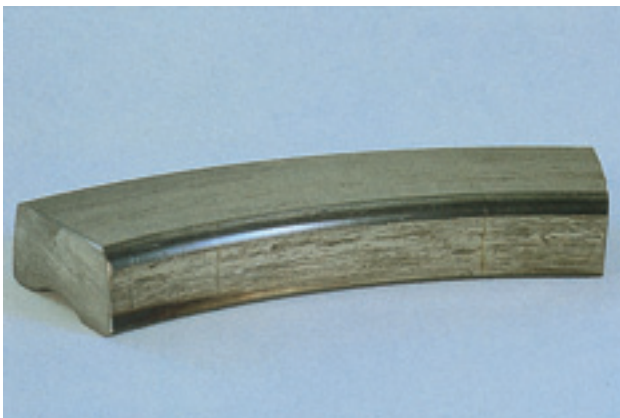
Photo P-3

- Inner ring of thrust ball bearing
- Spalling and friction cracking due to creep on bore wall.

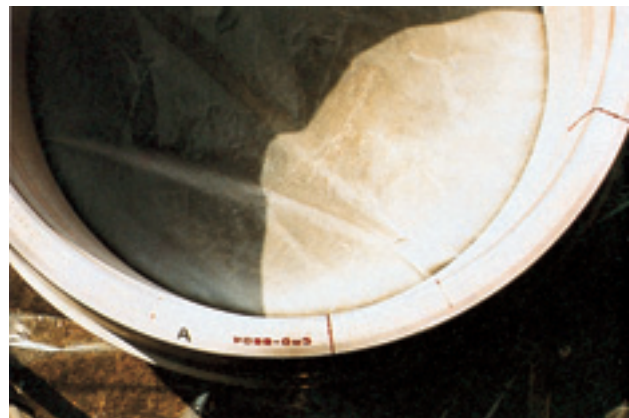
Photo P-4

- Inner ring of tapered roller bearing
- Spalling and friction cracking on width surface due to creep
Crack developed into a split reaching bore wall.
